An Evaluation of Illuminated Pedestrian Push Buttons in Windsor, Ontario

REPORT NO. FHWA-RD-00-102

August 2001

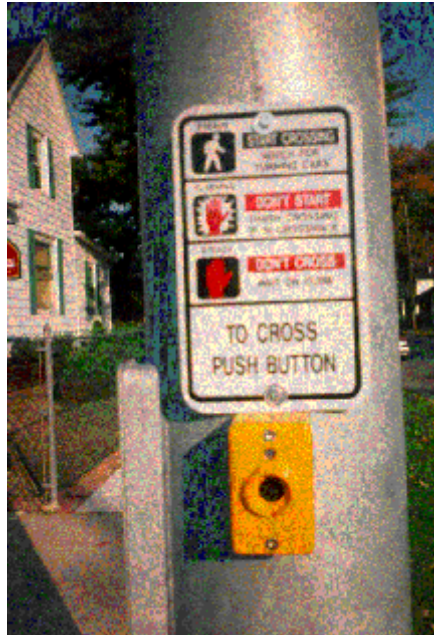
Figure 1. An illuminated push button in Windsor. The orange light is below the button.

The illuminated push button device that was evaluated in this study is the accepted design being used at hundreds of intersections in Canada. It has only a small orange light that may be difficult for pedestrians to see, particularly in the sun’s glare.

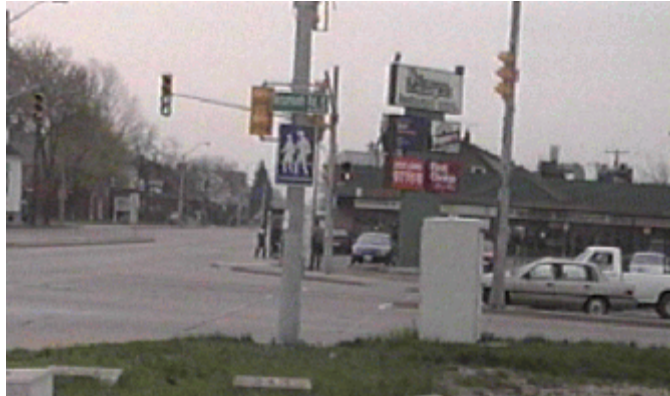
Figure 3. Tecumseh at Howard, west leg.

This is an intersection of two arterials (Figure 3). Tecumseh Road has five lanes, including the left-turn-only lane. The ADT is 26,000 and the speed limit is 50 km/h (31 mi/h). Both the east and west legs of Tecumseh have refuge islands. A high school is located near the southwest corner of Tecumseh Road and Howard Avenue. In addition, another school is three city blocks west of Howard, so many students who go to that school pass through the intersection of Tecumseh and Howard. Not surprisingly, most pedestrians at this intersection were students.

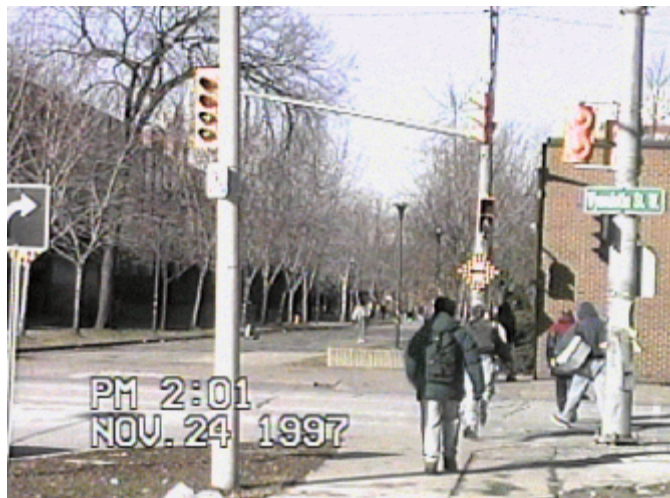
Figure 4. Wyandotte at Patricia, east leg.

Patricia Road is a north-south collector street two blocks to the west of Sunset. This is a T-intersection, and Patricia forms the south leg of the “T.” (Figure 4) At the intersection, Wyandotte has four lanes. The ADT on Wyandotte is 12,100 and the speed limit is 50 km/h (31 mi/h). The east leg of Wyandotte (but not the west leg) has a marked crosswalk and a pedestrian signal. The southside crosswalk is extra long, as pedestrians cross both Patricia and a bridge on-ramp, which is separated from Patricia by a raised median. The University of Windsor campus is to the north of Wyandotte. A mix of University buildings and single-family residences is to the south of Wyandotte. Pedestrian activity was steady during the periods of data collection.
